SERVICE BULLETIN SB/EUR/010 ISSUE 1
Kit and Factory Built Aircraft
Under-wing Fairings
14th November 2013

Classification: Essential

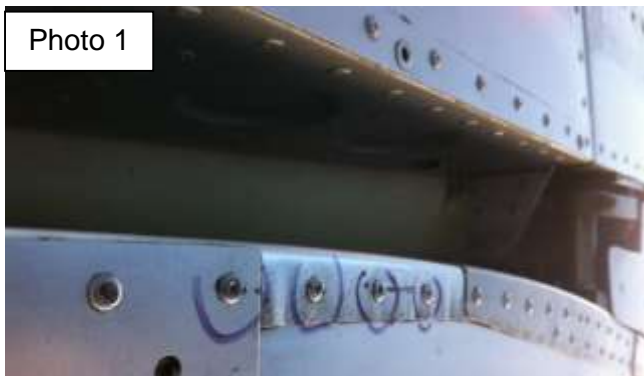
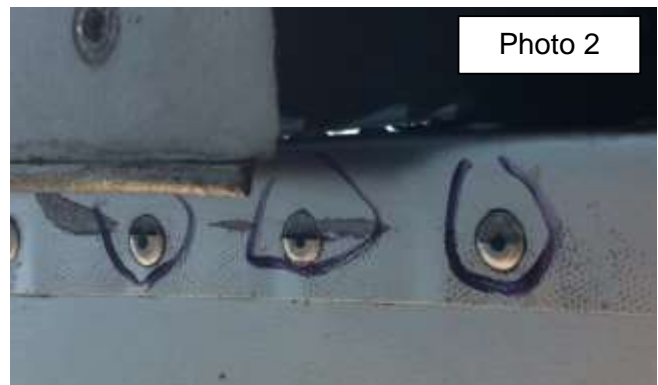
It was noticed on a recent CAA audit of a factory built aircraft with more than 1000 hours that the unattached sides of these fairings were rubbing against the fuselage causing damage to some rivet heads.

Photos.1 & 2 show damage to some rivet heads. Any rivet found with damage must be replaced. The rivets attach the lower fuselage longerons and failure of one or more rivets could compromise the structural integrity of the fuselage. The unattached side of these fairings will also need modifying to prevent further damage to these rivets.

1. Remove the fairings on both sides
2. Clean and inspect for rivet damage,
3. Mark each damaged rivet with a marker pen for reference (Photos. 1 & 2).
4. If there are no damaged rivets do items 4 to 6 in Rectification Action below.

If damaged rivets are discovered they will require replacement.

1. Contact Light Sport Aviation for a repair kit and instructions.

2. Rivets must be replaced by personnel acceptable to Light Sport Aviation or the BMAA
3. Replacement rivets must be checked by a qualified person
4. Add the inspection/rectification details to the airframe log book, referring to SB/EUR.010 Issue No1.
If there is no rivet damage the logbook entry should state -
'SB/EUR.010 Issue No.1. – No fault found'
5. Whether damage is found or not, to prevent damage to rivet heads a strip of Velcro (hook side only) must be applied to the inside of the fairing Photo 3. A self-adhesive Velcro 20mm in width fitted to the entire length of the fairing, alternatively the Velcro can fixed with a contact adhesive such as Evostick.
6. Re-fit the fairings on both sides.
