Light Sport Aviation Limited

24th October 2016

Re: Eurostar EV-97 Wing Spar Caps

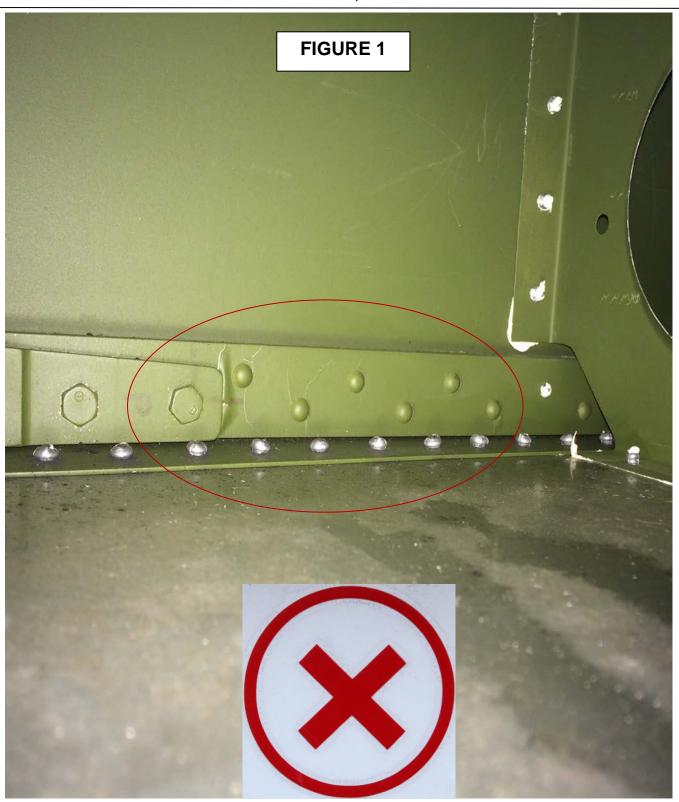
LSA has received information from two Eurostar owners regarding the wing lower spar cap which on inspection has shown cracking of the paint which may indicate unusual movement of the joint between the fuselage and the wing root (figure 1). The cause of this and extent within the UK fleet of Eurostar EV-97 aircraft is currently unknown.

As an interim measure and until LSA understands this anomaly, we strongly suggest that you inspect your lower spar caps around the 5th bolt outboard of the wing to fuselage attachment bracket shown in figure 1. The lower attachment should look as in figure 2. If you observe paint cracking or any other difference from that shown in figure 2 **DO NOT FLY** the aircraft. After inspection inform LSA of your findings by phone or email even if you find no differences. Please do not disturb the paint if you discover anything suspicious, as this could destroy any evidence present. A simple questionnaire is attached. Your feedback will enable LSA to evaluate the extent and occurrence of this anomaly.
