SERVICE BULLETIN SB-EV97-UK-014 Issue 1
Kit Built Eurostar Aircraft, Aileron Rose Joint
1st June 2012

Classification: - Recommended

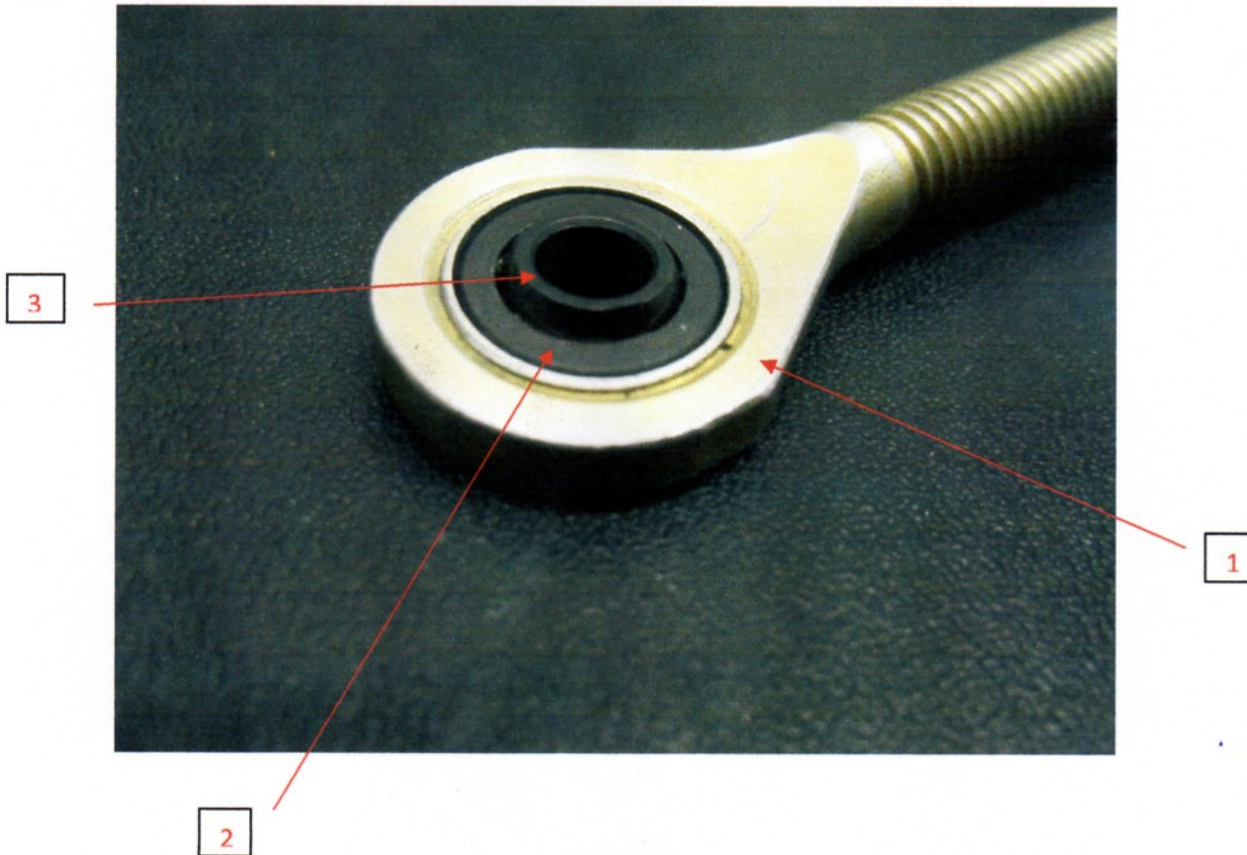
Photo 1 shows an assembled rose joint, which consists of an eye piece 1, with a thread for screwing into the pushrod, an intermediate ring 2 and a central spherical insert 3 which can swivel for alignment. The intermediate ring 2 is swaged both sides to hold it into the eye piece.

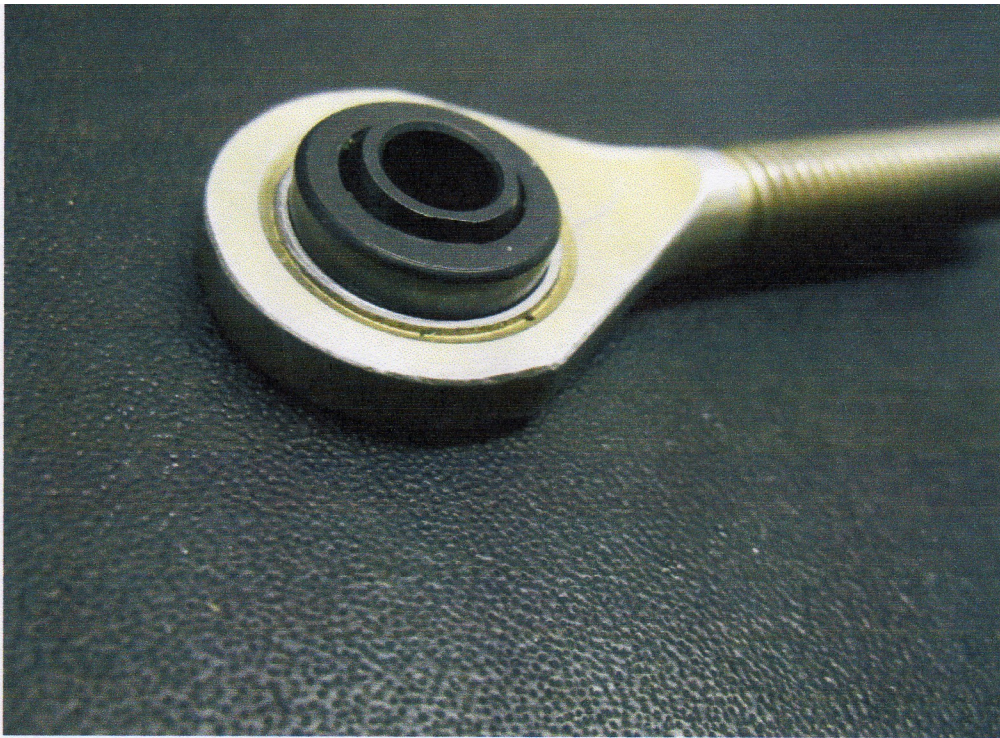
During the build of an aircraft it was found that on one rose joint the intermediate ring 2 was not swaged in place on one side, allowing it to easily slide out of the eye. Photo 2 shows the intermediate ring which slid out of the eye, with the spherical insert inside it.

Rose joints are used in various places in the control systems but in most of the installations there is no potential for an unswaged intermediate ring to disconnect from the eye. The only joint that this could partially happen to is at the bottom of each of the control columns.

If a faulty rose joint is found, then contact Cosmik Aviation for a replacement, and for fitting instructions.

If a replacement rose joint is fitted, have a qualified person check the work, then enter the details in the aircraft logbook, referring SERVICE BULLETIN SB-EV97-UK-014-ISSUE 1.

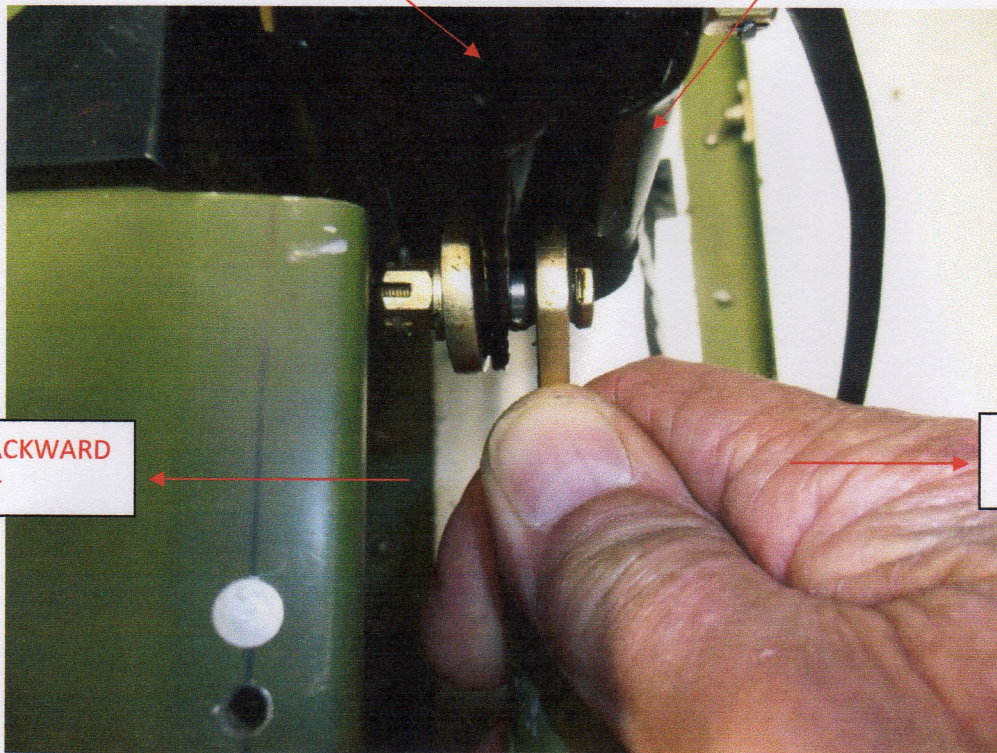
Photo 3 – Right hand side (starboard) shown

Referring to Photo 3, which shows the bottom of the right hand (starboard) stick, it can be seen that a bolt with castellated nut holds 2 rose joints to the bottom of the control stick. The left hand rose joint, next to the castellated nut, is not affected by this bulletin. The rose joint on the right hand side (being held by a thumb and forefinger) is affected. The central spherical insert and the intermediate ring are secured by the bolt, but if the eye is not correctly swaged, it could be possible for it to slide off the intermediate ring (in a right hand direction on the photo, towards the front of the aircraft).

There is no washer behind the bolt head to prevent this, as a washer would restrict the movement necessary for alignment. The eye cannot, however, become completely detached as it comes into contact with the housing before it can clear the bolt head, but if it did slide this far considerable play would exist with the possibility of aileron flutter and some difficulties in precise roll control.

- 1) Visually check that the intermediate ring is central in the eye piece as in Photo 1 (ie it has not moved out in either direction as in Photo 2). If it has moved the complete joint must be replaced. If it has not moved, or if you are unsure, continue with the following check.
- 2) Grasp the rod end firmly with a thumb and forefinger as shown in Photo 3, and try to move the rose joint forwards and backwards (ie to the right and left in the photo.) While doing this wiggle the rose joint to make sure it is not sticking. It should be possible to apply a force of about 5 kg fore and aft with finger pressure. Repeat several times to be sure there is no movement.
- 3) If the rose joint moves as shown in Photo 2, then the rose joint must be replaced with a new one.
- 4) Repeat the test on the other side.

If no fault is found, make a logbook entry that the Service Bulletin has been complied with and no fault found. Mark the affected rose joints on both sides with a dab of red paint (nail varnish is ideal) for future indication that the check has been carried out.
