## SERVICE BULLETIN SB/EUR/023, Issue 3

### **Evektor Eurostar Aircraft, Aileron and Rudder Rose Joints 1st Oct. 2025**

**Issue 3:** Details added for rearward test; new Evektor-sourced joints' test added; "Inspections" modified;

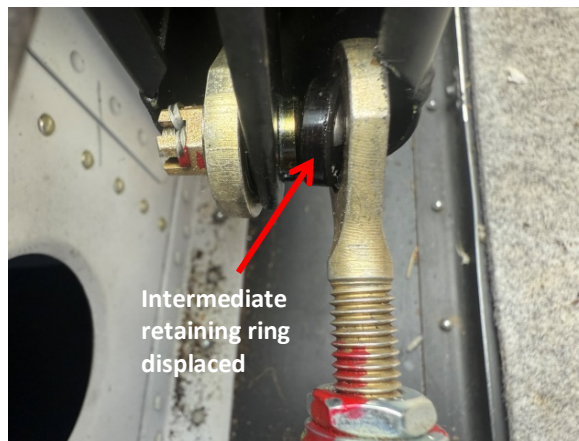
There have been reports of failures of the rose joint (rod end) connecting the bottom of the control stick to the aileron push rod. In one instance, the centre of the rose joint had become displaced and jammed the aileron control. A subsequent investigation revealed that it could be disconnected completely. This aircraft was factory-built in 2010 and had completed 493 hours; a second, built in 2011, 1100 hrs; a third, built in 2015, 1301 hours.

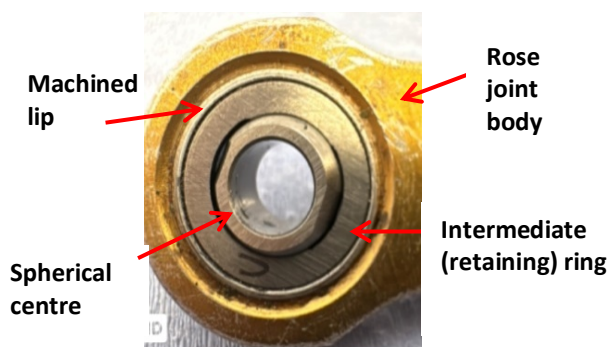
The rose joint assembly is shown on the right. During manufacture a thin lip is machined in the body of the joint and swaged over on each side to secure the intermediate, retaining ring. On the failed joints this swage was not present, or was inadequate, allowing the retaining ring with its spherical centre to move out of the body.

**(i) Loose intermediate (retaining) ring:** Where the aileron push rod 8688 connects to the bottom of the control stick via a rose joint, clean off any grease or dirt from the joint. Using a torch and mirror, carefully examine the rose joint. The edge of the retaining ring should lie flush with the inner edge of the body around the entire perimeter of the ring. Push the retaining ring firmly around its perimeter to check that it is not cocked and jammed in the body. There should be no movement. If the retaining ring has become displaced from the body, replace the rose joint. Also conduct the following two checks after replacement.

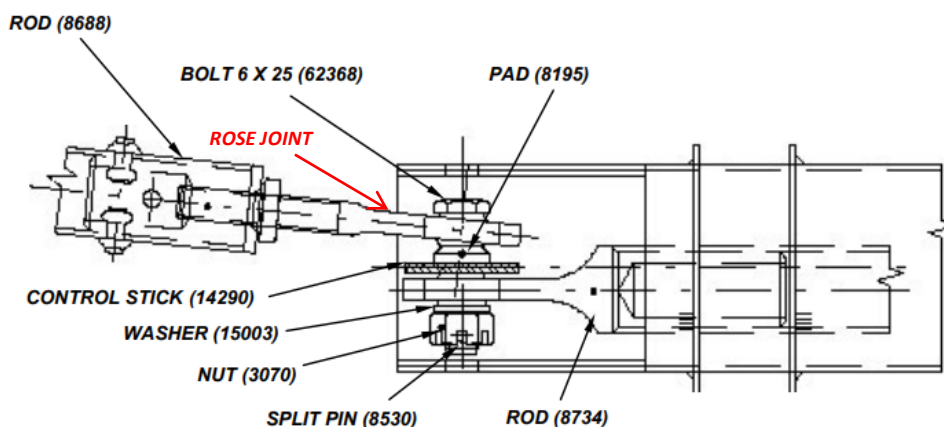
**(iii) Correct Assembly:** the correct assembly is shown below. The "pad" (8195) is an essential component ensuring that the joint can move freely over the control stick's fore-aft angular range. Note that the bolt 6 x 25 (62368) is a special fastener with a ground shank and 9mm head.

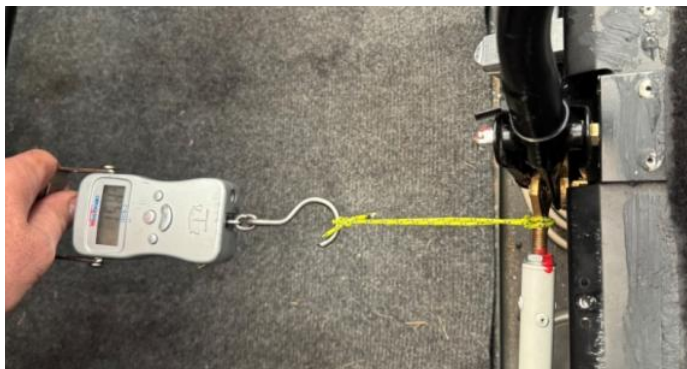
It is necessary to apply loads to the rose joints to check that the centres are securely held in their housings. This can be done in situ. Using a spring balance, apply a forward load of 12kg to the body of the aileron push rod's rose joint as near to the 6mm bolt as possible and perpendicular to the plane of the rose joint. See method on the right.

Check that this has not resulted in any movement of the retaining ring within the body of the rose joint.

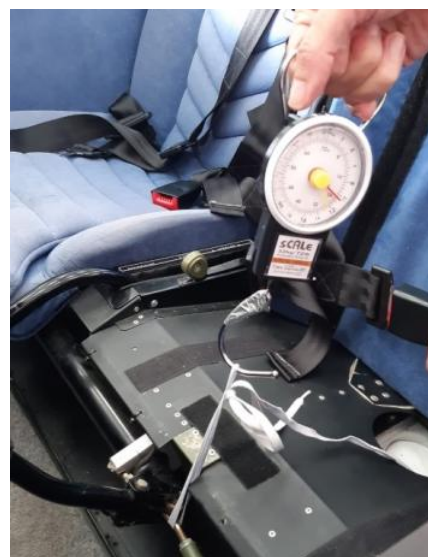
Remove the seat cushion and push the stick fully forward. A spring balance can then be used behind the assembly to apply the load perpendicular to the plane of the rose joint. Repeat the above test, applying the load rearwards. See method on the right.

Check again that there has been no movement of the retaining ring within the body of the rose joint.

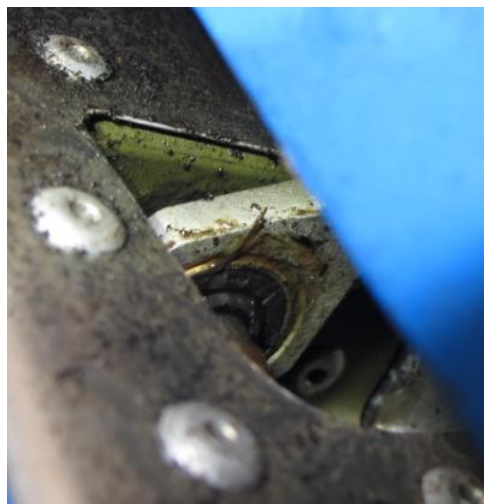
The rudder's upper hinge must be carefully inspected to ensure there has been no movement of the retaining ring within the body of the rose joint. The inspection is more easily carried out by two people: one to hold the rudder over to one side, the second to carry out the inspection. If such help is not available, ensure the rudder is pushed and held firmly and safely to one side by a strap or adhesive tape for the inspection. Be aware of a finger trap and risk of injury between the trailing edge of the fin and leading edge of the rudder if the rudder is accidentally released.

With the rudder held firmly over to the left, carefully clean off any grease or dirt on the rose joint. Then, using a torch and small dental mirror, examine the underside of the rose joint (it is not possible to examine the upper side). Ensure that the retaining ring is fully home in the rose joint body, as shown on the right, and that there is no evidence of tipping, misalignment or looseness of the joint. If it is not possible to see the retaining ring clearly then an endoscope must be used.
