SERVICE BULLETIN SB/EUR.020 Issue 1

Eurostar Aircraft, Engine Mount Bolts

27th Oct. 2023

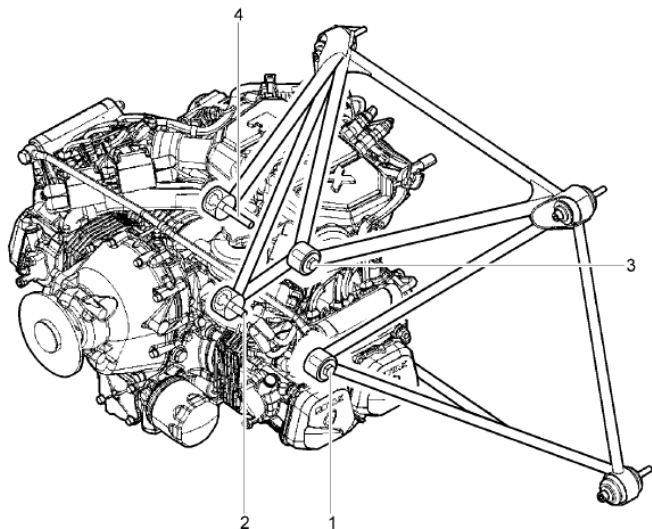
There have been isolated occurrences of failure of the M10 bolts securing the Rotax engine to its frame. The failure cause is thought to be fatigue caused by the bolts losing their tensions permitting movement between engine and engine mount.

1. Gain access to the heads of each of the 4 off M10 cap head bolts, 1 – 4, securing the engine to the engine mount, as shown on the right:
2. Remove the black plastic plugs from the bolts' heads and discard them.
3. Check the torque on bolts 1, 2 and 3 at 35Nm. If the bolt moves at this torque, remove the bolt completely, discard it and replace as detailed below.
4. Tighten bolt 4 to 40Nm.

Note: it is often possible to see if there has been inadequate tension on the bolt by the presence of dark grey dust between engine block and engine mount at the mating surfaces.

4. Replace each loose bolt with an M10 x 35, 10.9 cap head, bright zinc plated. A replacement kit is available from Airmasters. Apply two drops of Loctite 221 to the thread before installation and torque to 40Nm.
