**EVEKTOR - AEROTECHNIK a.s.**

**MANDATORY BULLETIN No.:**

**EV97 – 026a**

- 1. CONCERNING:** All models of EV-97 EuroStar airplanes manufactured till the end of 2006 (all S/N up to 2006xxxx including).
- 2. REASON:** The fairings between the lower part of the wing and the fuselage are attached to the wing by bolts, while not being attached to the fuselage. The free ends of the covers are touching the rivet heads on the fuselage surface. Friction due to vibrations in operation can cause damage of rivet heads, which endangers the structural integrity of the fuselage.

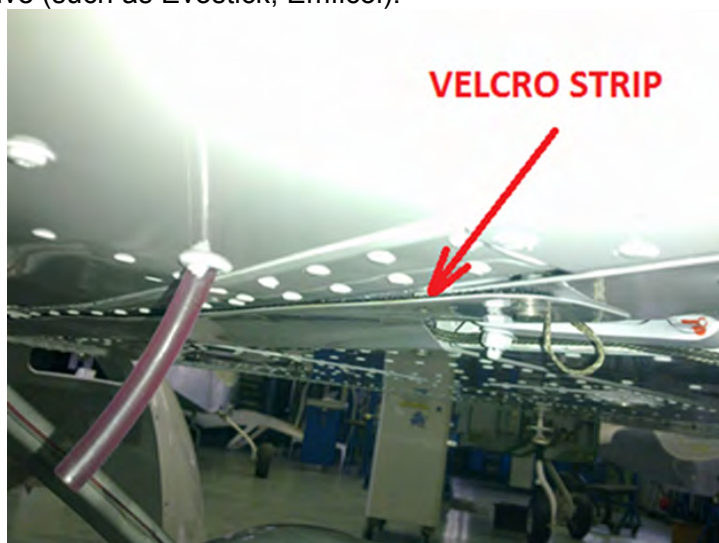
Fig.1 General view of the cover on the airplane

Remove the lower fairings covering the gaps between the fuselage and the wing (see Fig.1.3).

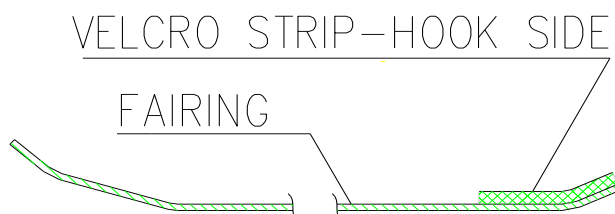
Fig.2 Cover modification

Stick the velcro (Velcro tape, the part with hooks) on every cover, in order to prevent from abrasion of rivet heads on the fuselage. According to Fig.2 stick the velcro along the length of the cover onto its inner side in the position adjacent to the fuselage. Clean and degrease the surfaces before adhesive bonding. Use the self-adhesive velcro of 20 mm width; eventually fix the velcro without adhesive by means of a contact adhesive (such as Evostick, Emficol).

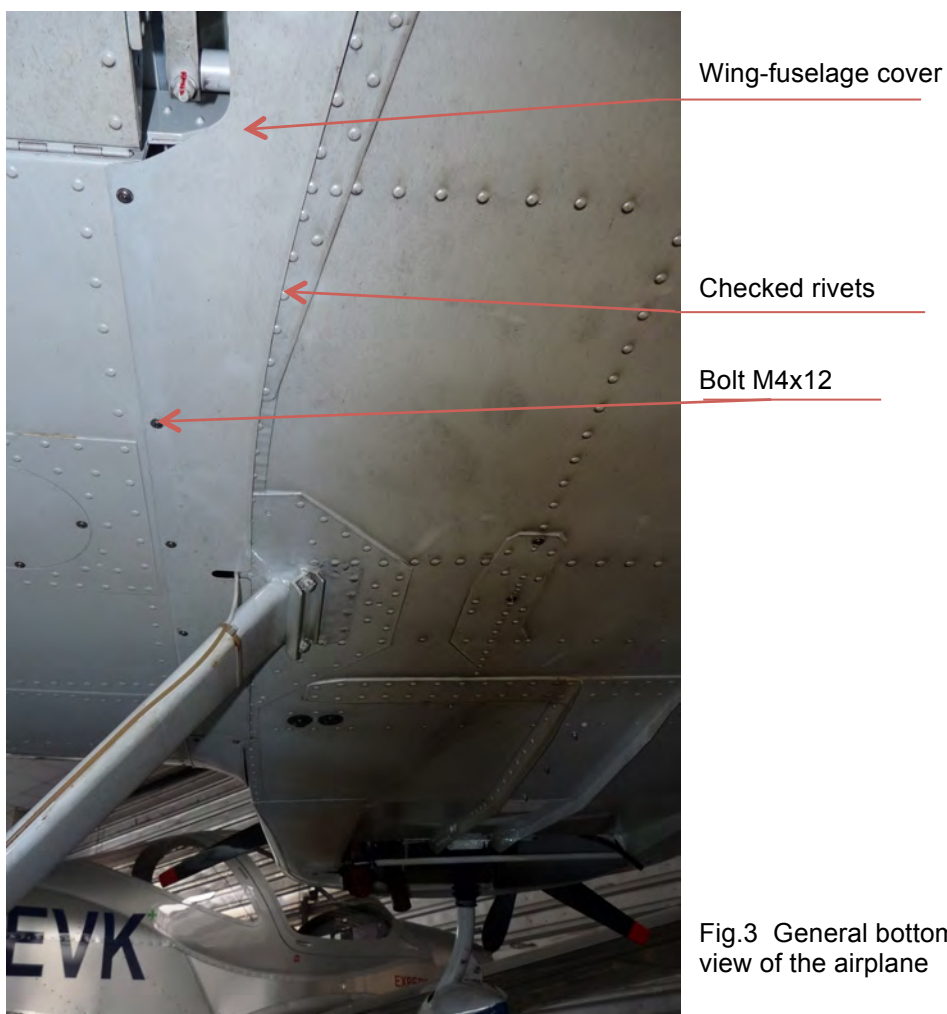
Clean the rivet heads located on the fuselage surface under free ends of the fairings (see Fig. 3, 4, 5) from impurities and check whether they are not damaged (abraded). Every damaged rivet must be marked with the marker.

Fig.3 General bottom view of the airplane

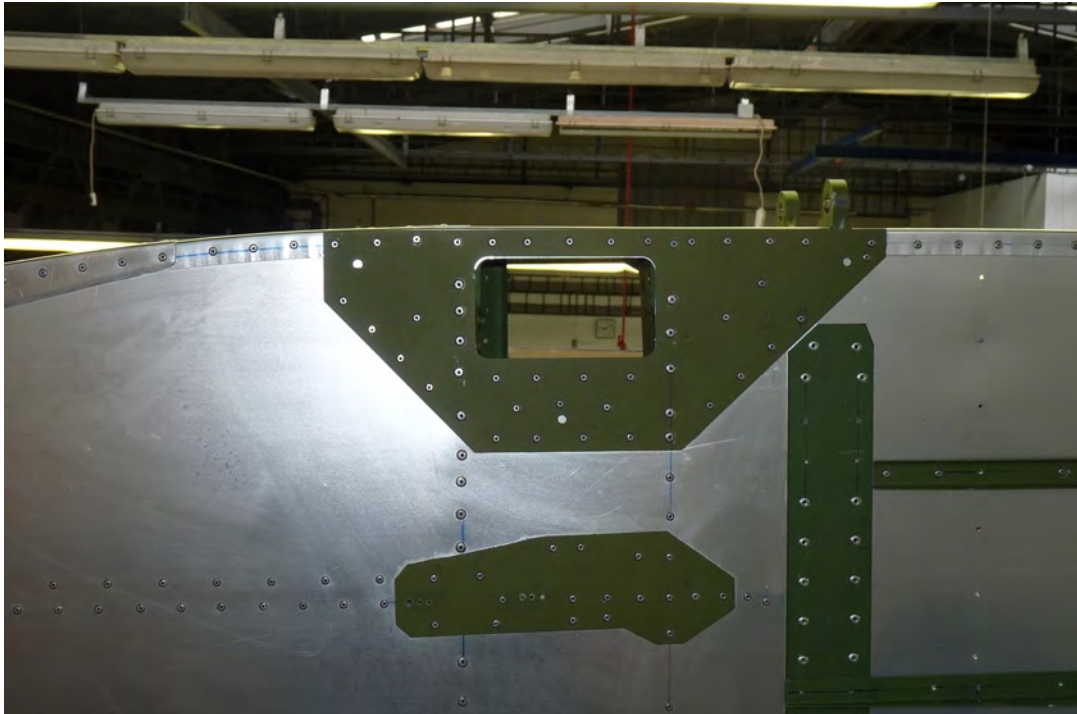
Fig.4 Bottom view of the fuselage in the area of wing-fuselage front attachments

Remove the damaged rivets marked according to point 1.3 and replace them by new ones.

- Eject the spindle from the rivet by the steel ejector whose diameter is by 0.1 to 0.3 mm smaller than spindle diameter.
- Drill the rivet head by means of the bit which is identical with rivet shank diameter. The hole for the rivet mustn't be, however, damaged!
- Eject the rest of rivet shank (by the mandrel with bevelled edge of face area), whose diameter is smaller than rivet hole diameter in order to prevent from damaging the hole.
- Clinch the rivet, mentioned in Fig.6, in the hole.
- Check the rivet joint by appropriately qualified person.
- Coat the heads of the exchanged rivets by Rapid sealant, grind with fine sand paper and paint with primer Metallgrund 2200 and top coat Glasurit R18.

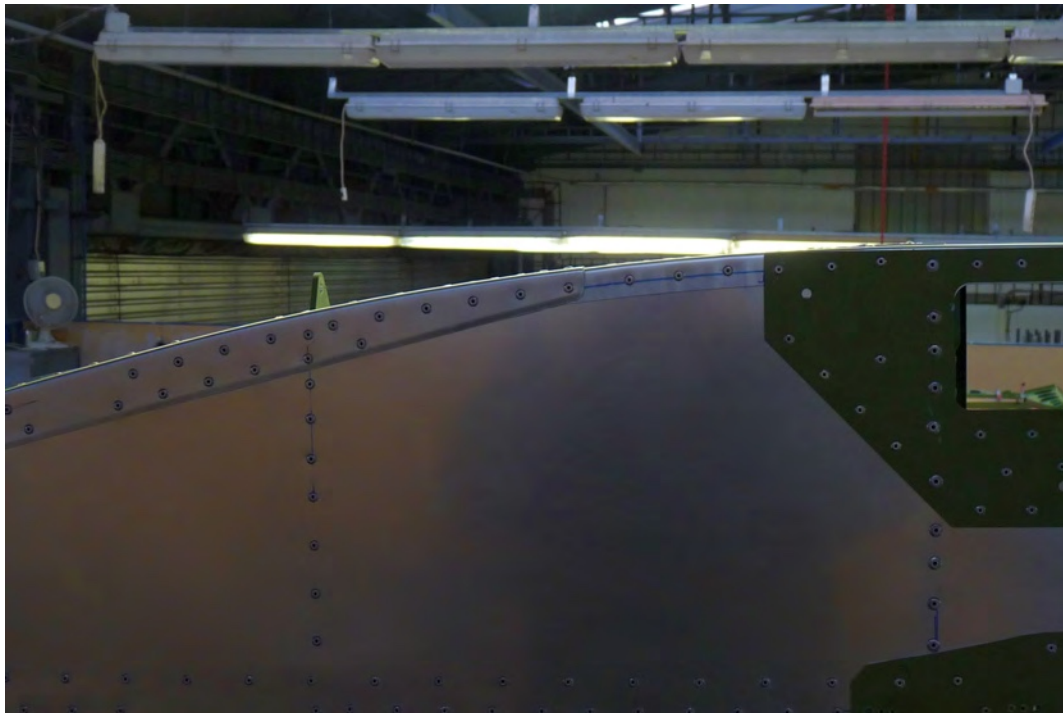
Fig.5 Bottom view of the fuselage in the area of the wing-fuselage rear attachment

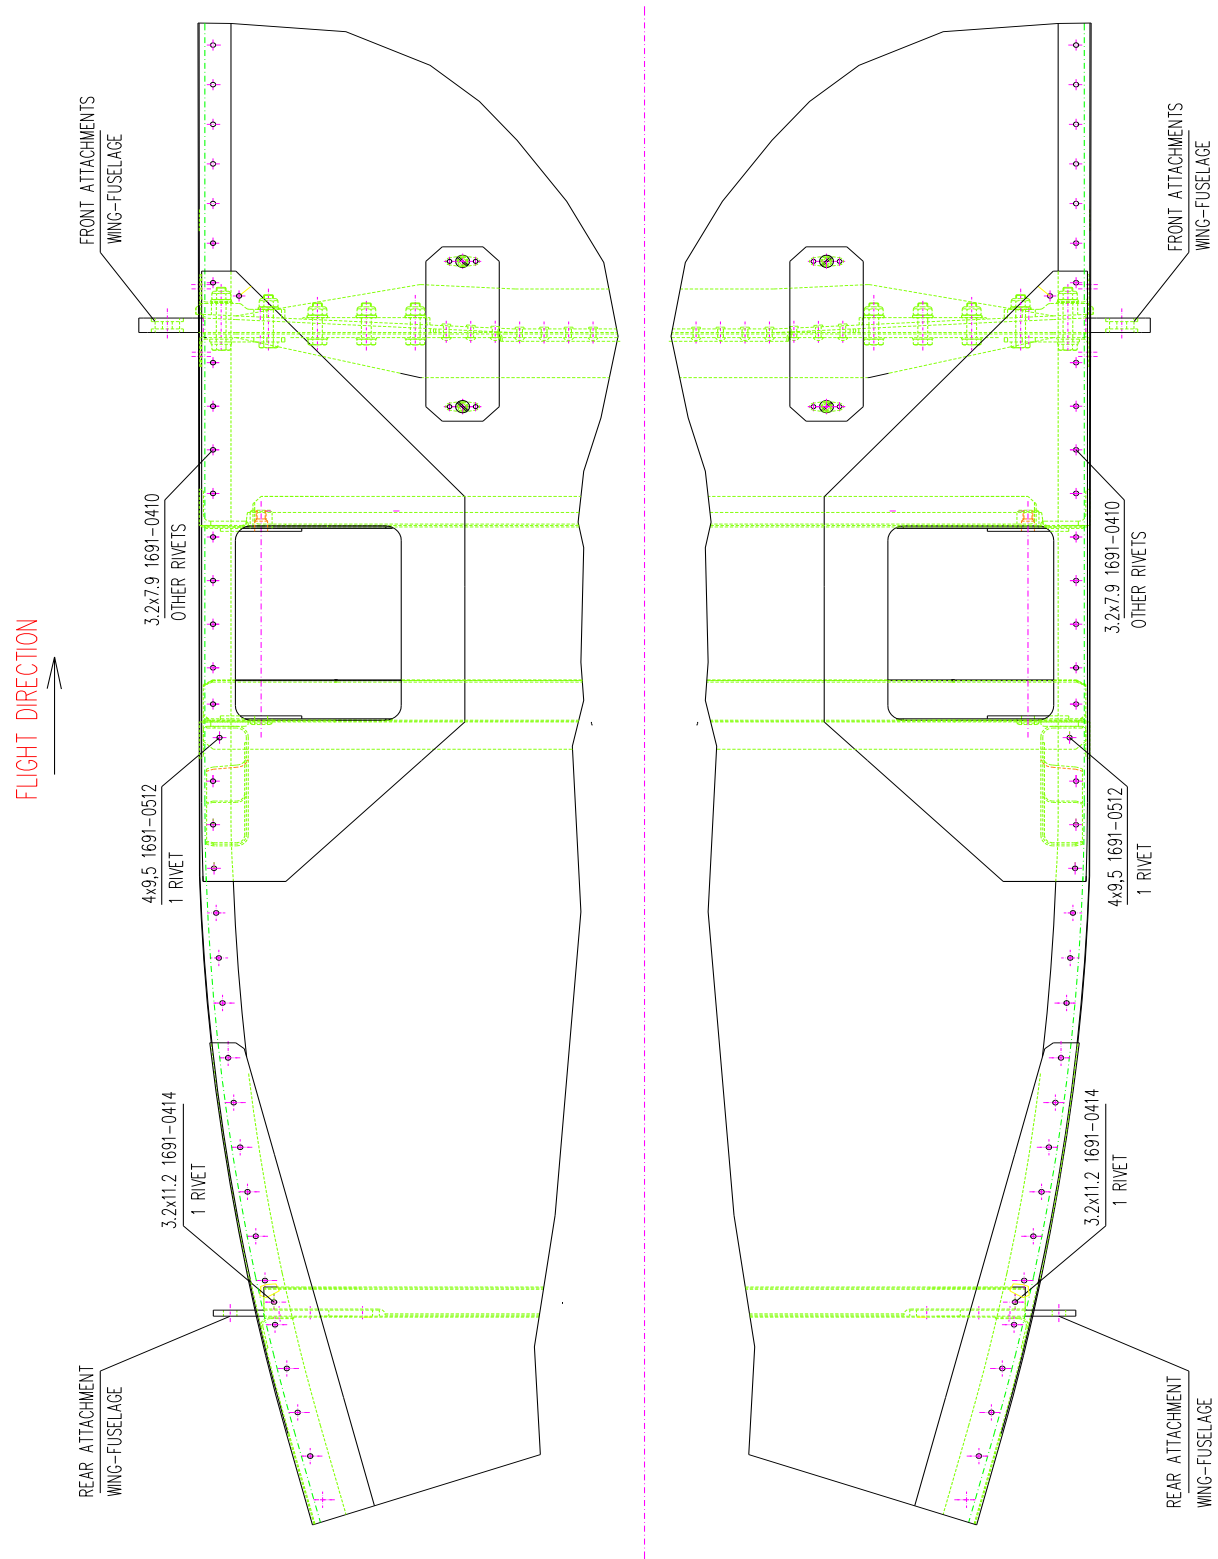
Fig.6 View of the rivets on the lower side of the fuselage
