COSMIK AVIATION

12th August 2007

KIT BUILT EV-97 EUROSTAR AIRCRAFT
SERVICE BULLETIN SB-EV-97-08
TRIM CABLE CLEVIS PIN RETAINER

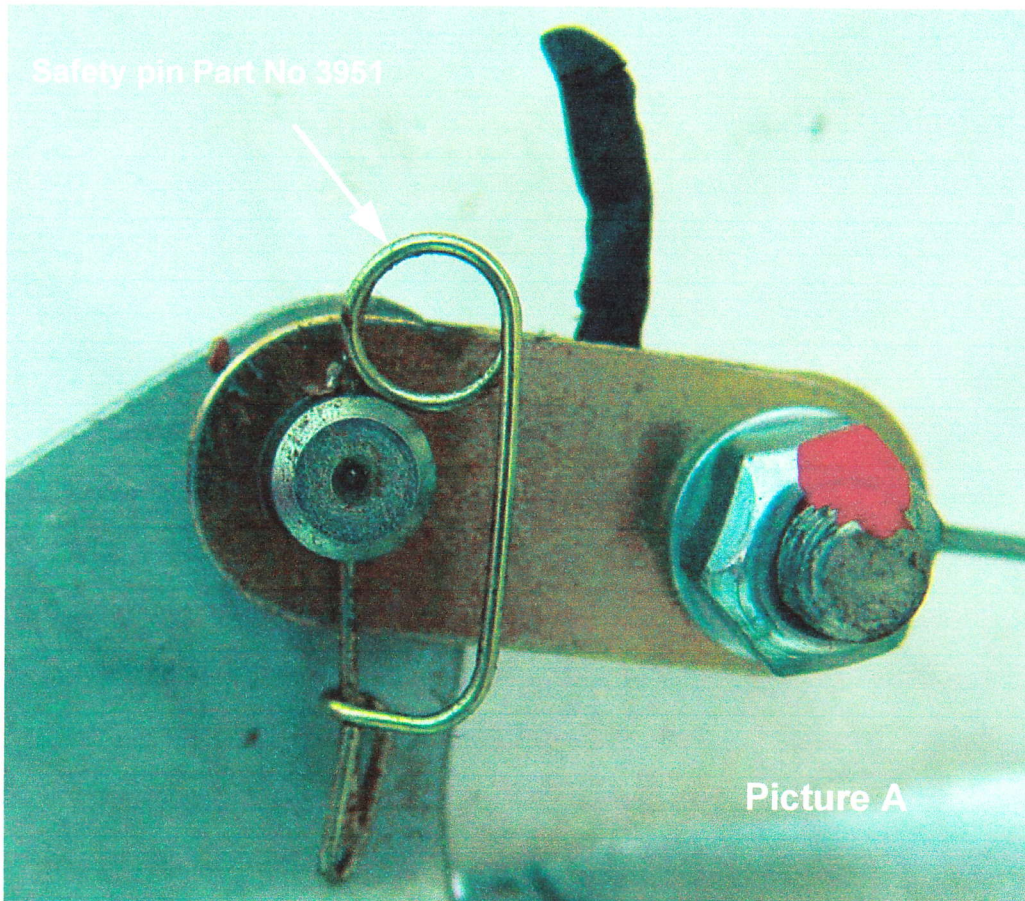
There is a possibility that during cleaning, handling or fitting/removing aircraft covers the safety pin, part No 3951, retaining the trim cable clevis pin to the trim tab horn could become unclipped and fall out. (See picture A)

A normal pre flight inspection should cover this area, but if missed and the safety pin were to fall out and subsequently allow the clevis pin to fall out, loss of the elevator trim control would result.

Remove the safety pin, part No 3951, from the top trim cable clevis pin (picture A) and replace with split pin 2 X14, (part No 3188 available from Cosmik) as per picture B. Bend the ends of the split pin as in the picture to secure the split pin and prevent them being caught by cleaning rags, aircraft covers, ETC.
Repeat the above procedure for the lower trim cable clevis pin.
