SERVICE BULLETIN SB/EUR/08 ISSUE 1

Factory Built Eurostar Aircraft, Aileron Rose Joint

1st June 2012

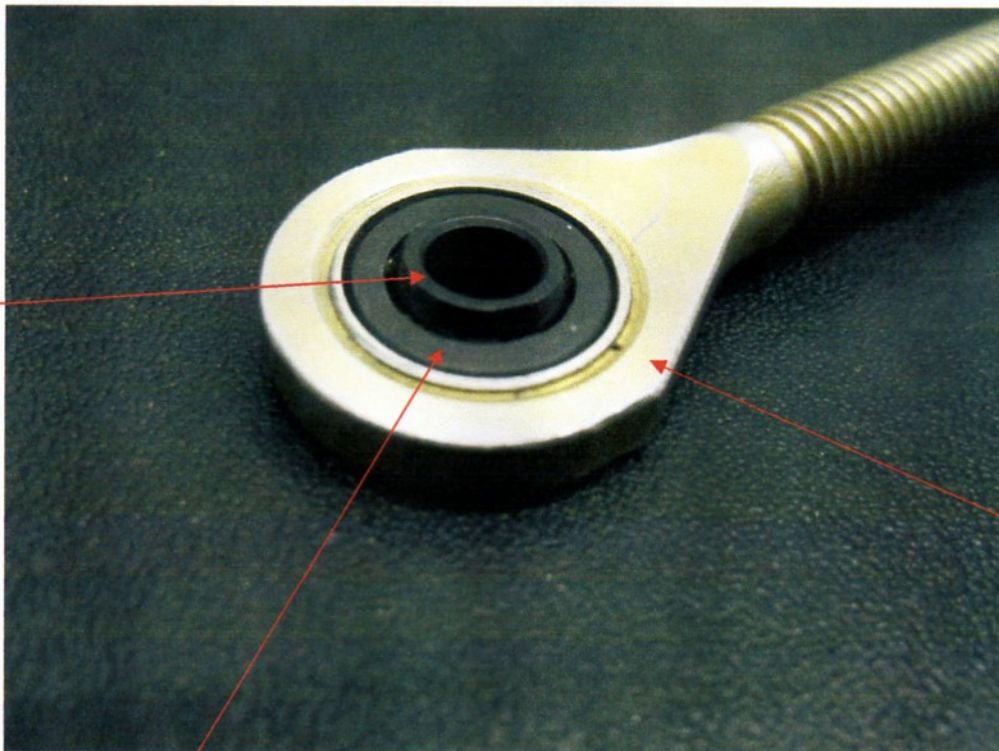
Photo 1 shows an assembled rose joint, which consists of an eye piece 1, with a thread for screwing into the pushrod, an intermediate ring 2 and a central spherical insert 3 which can swivel for alignment. The intermediate ring 2 is swaged both sides to hold it into the eye piece.

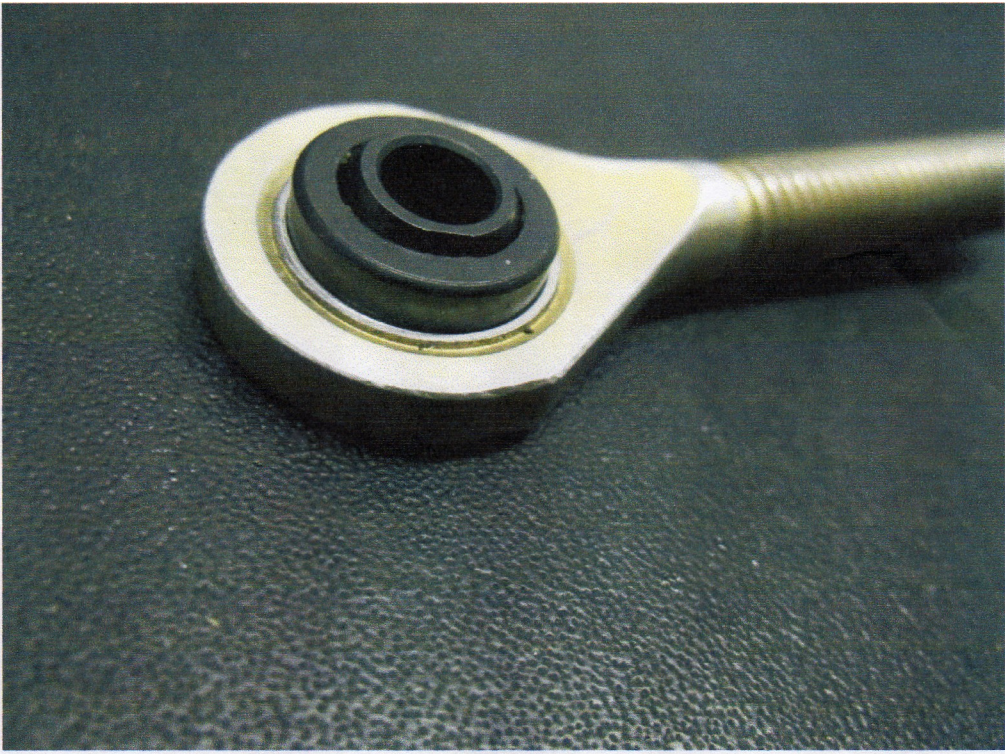
During the build of an aircraft it was found that on one rose joint the intermediate ring 2 was not swaged in place on one side, allowing it to easily slide out of the eye. Photo 2 shows the intermediate ring which slid out of the eye, with the spherical insert inside it.

- 1) Visually check that the intermediate ring is central in the eye piece as in Photo 1 (ie it has not moved out in either direction as in Photo 2). If it has moved the complete joint must be replaced. If it has not moved, or if you are unsure, continue with the following check.

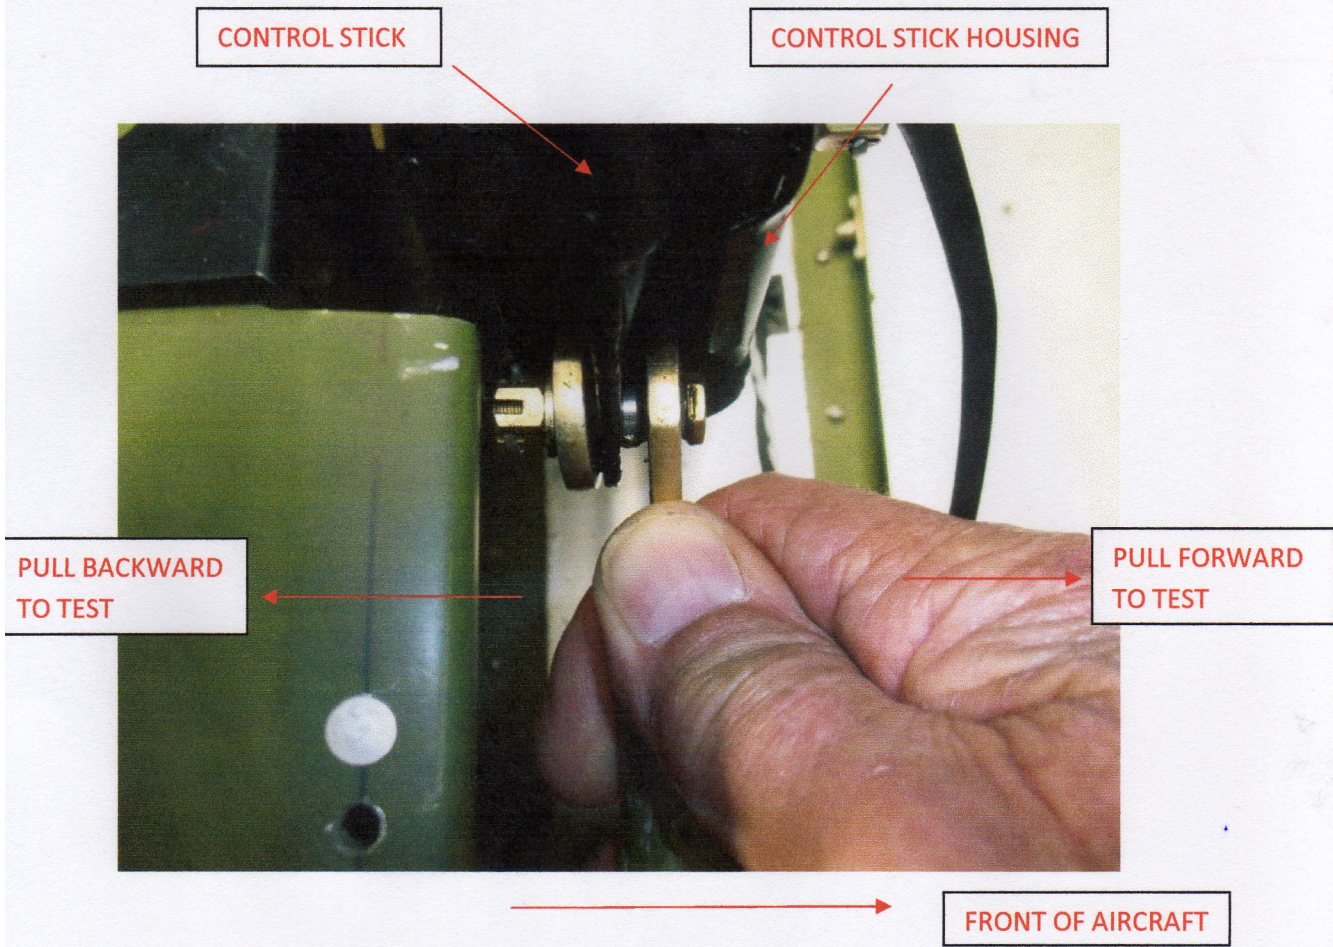
Photo 3 – Right hand side (starboard) shown

Referring to Photo 3, which shows the bottom of the right hand (starboard) stick, it can be seen that a bolt with castellated nut holds 2 rose joints to the bottom of the control stick. The left hand rose joint, next to the castellated nut, is not affected by this bulletin. The rose joint on the right hand side (being held by a thumb and forefinger) is affected. The central spherical insert and the intermediate ring are secured by the bolt, but if the eye is not correctly swaged, it could be possible for it to slide off the intermediate ring (in a right hand direction on the photo, towards the front of the aircraft).

There is no washer behind the bolt head to prevent this, as a washer would restrict the movement necessary for alignment. The eye cannot, however, become completely detached as it comes into contact with the housing before it can clear the bolt head, but if it did slide this far considerable play would exist with the possibility of aileron flutter and some difficulties in precise roll control.

- 2) Grasp the rod end firmly with a thumb and forefinger as shown in Photo 3, and try to move the rose joint forwards and backwards (ie to the right and left in the photo.) While doing this wiggle the rose joint to make sure it is not sticking. It should be possible to apply a force of about 5 kg fore and aft with finger pressure. Repeat several times to be sure there is no movement.
- 3) If the rose joint moves as shown in Photo 2, then the rose joint must be replaced with a new one.
- 4) Repeat the test on the other side.

If a faulty rose joint is found, then contact Cosmik Aviation for a replacement, and for fitting instructions.
