SERVICE BULLETIN NUMBER CT 123	ISSUE 1	PAGE 1 of 4
---------------------------------------	----------------	--------------------

TITLE	Inspection of main undercarriage legs for deformation and cracks.
CLASSIFICATION	The CAA have classified this bulletin as Mandatory.
COMPLIANCE	For aircraft with main undercarriage which have in excess of 300 flying hours: within 5 flying hours. For aircraft which have suffered a heavy landing: before further flight.
APPLICABILITY	300+ hour check - All CT2K and CTSW aircraft first registered before 22nd February 2007. Heavy landing check - applies to all CT2K and CTSW.

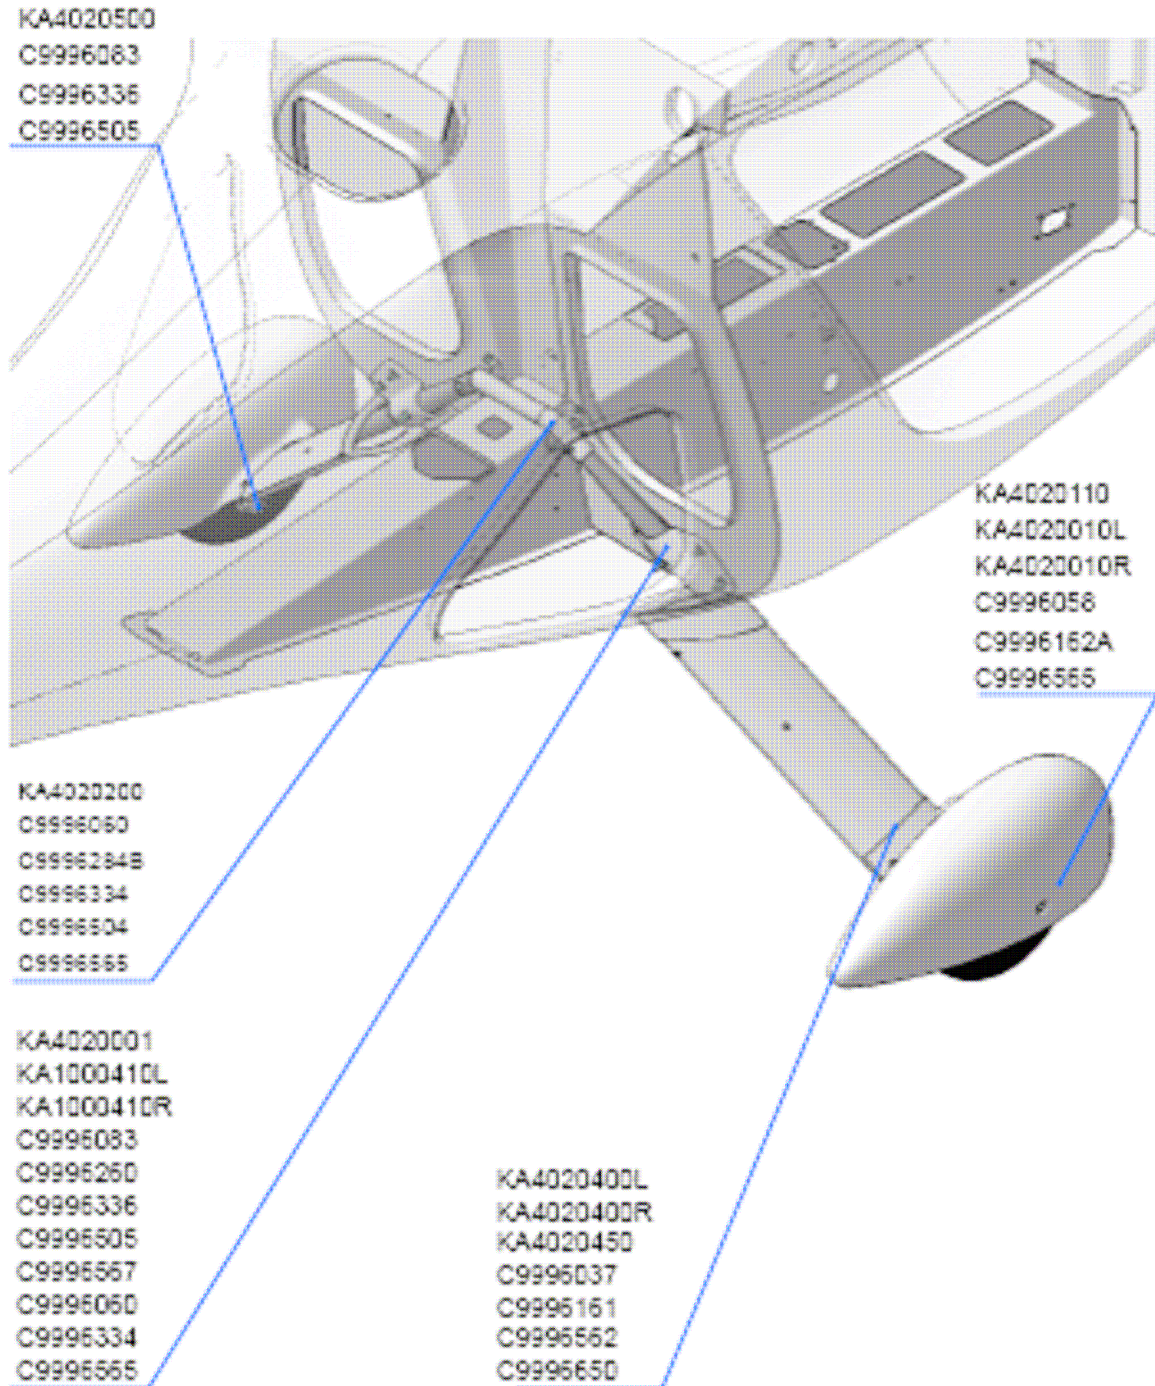
Fig. 1. General arrangement.

The port main undercarriage leg on a CT2K S/N 7921 (Flight Designs No. 02-06-01-04) failed when taxiing. The aircraft was used in the training role for most of it's life and had more than 800 airframe hours including the main undercarriage. The leg failed due to fatigue cracking at the neck, where it plugs into a steel fitting in the fuselage. The leg was also slightly bent and also had a crack at the main pivot hole aft side. The leg is machined from 7075-T6 aluminium alloy. See fig 1 general arrangement.

The undercarriage leg is stepped up in diameter where it enters the steel fitting. It is also bored in 2 diameters for lightness, forming an internal step in the same area.

Fatigue failure of the leg was exacerbated by the preload of the neck. The fatigue crack grew from the external step corner.

From serial no 06-12-18 the larger counterbore in the top of the leg has been omitted, so removing the internal step with a weight penalty of a few grammes.

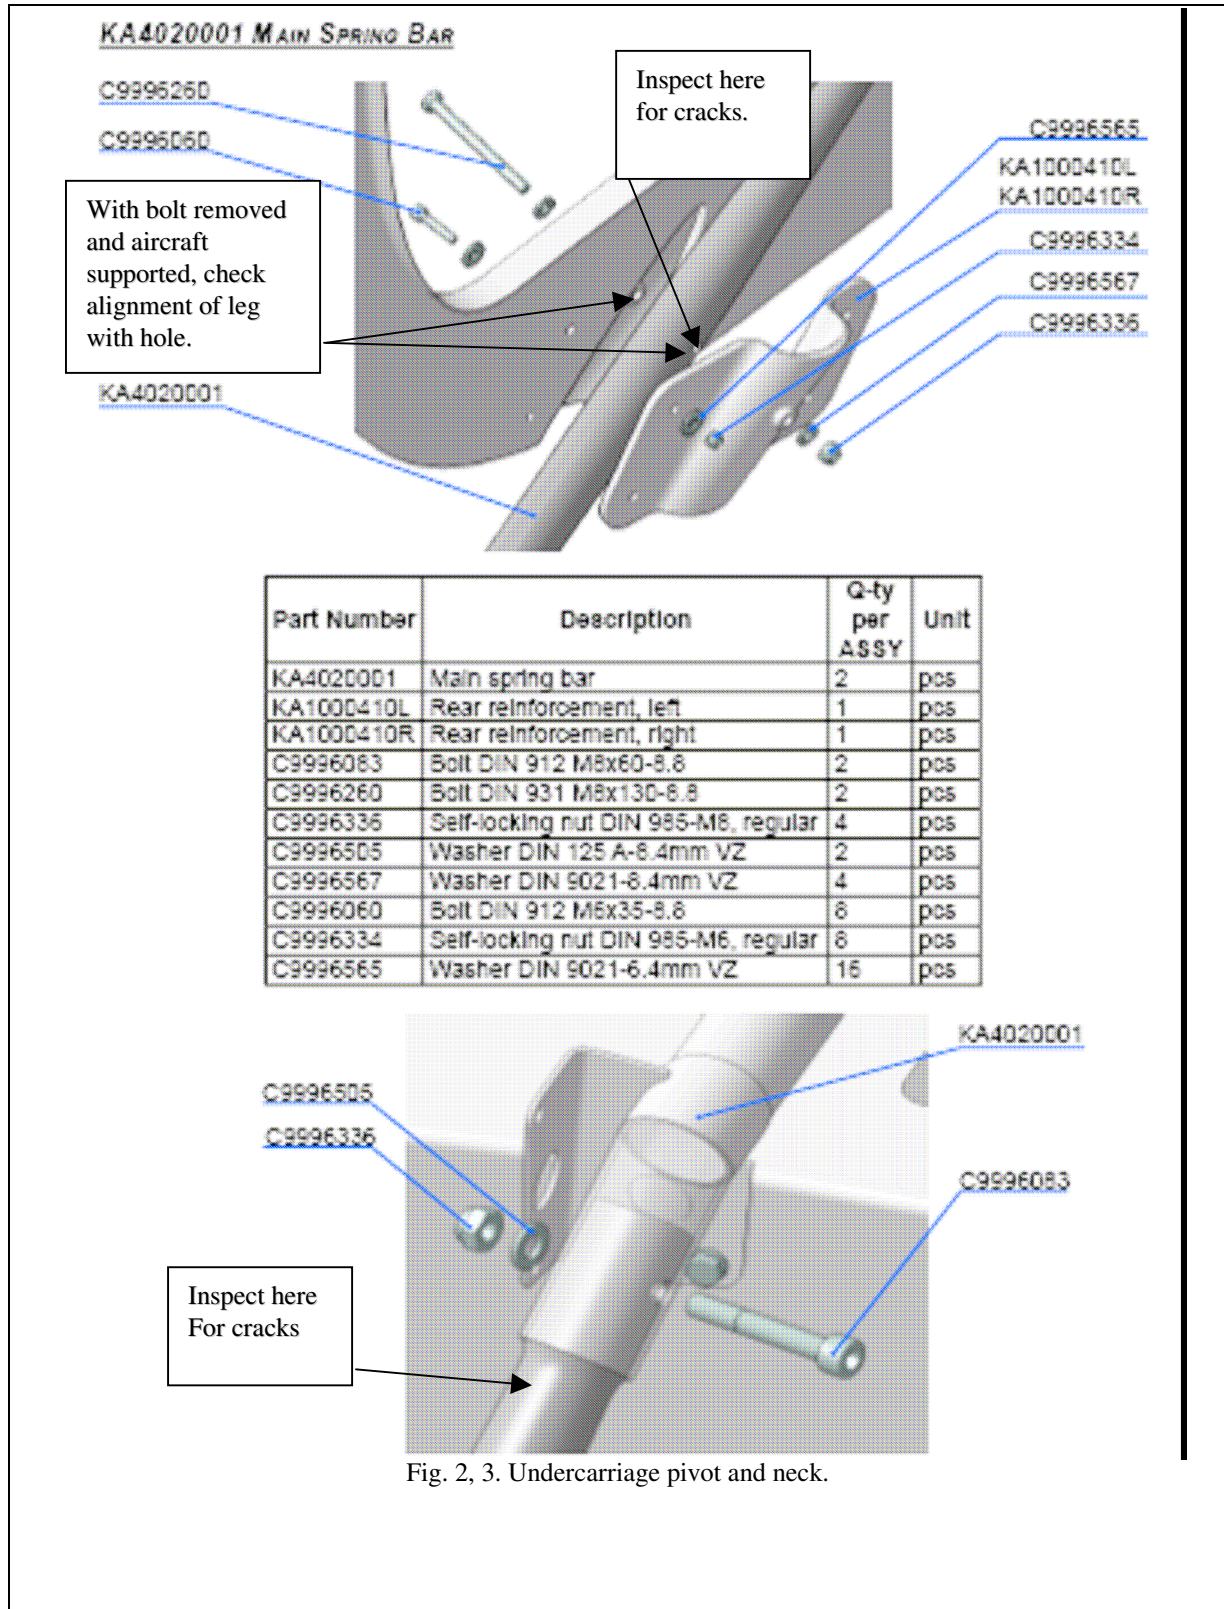
It was noted that when a new replacement leg was plugged into the steel fitting it did not align well with the main bulkhead pivot attachment hole, causing an untypical bending moment to be applied to the top of the leg. See figs 2 and 3. To achieve alignment, the leg had to be forced upwards, causing a preload to be added to the normal operating loads. The undercarriage leg top steel fitting had been replaced during the life of the aircraft according to modification M134 (addition of vertical shear bolts to the fuselage tunnel).

8) Check the alignment of the undercarriage leg top fitting with the bulkhead pivot bolt. With the leg inserted into the top steel fitting, the main pivot bolt must align without having to use excessive force; this means the pivot bolt must align to within 1mm of the bulkhead mounting holes. If the leg does not align, then it is allowable to adjust the top steel fitting shims until alignment is achieved. Contact P&M Aviation if there is difficulty achieving alignment.
