SERVICE BULLETIN SB/EUR/019 ISSUE 1
EV-97 Eurostar Amateur Kit and Factory Built Aircraft
Cracking of the rear fuselage bulkhead

Date: 12 July 2016

Classification: Essential

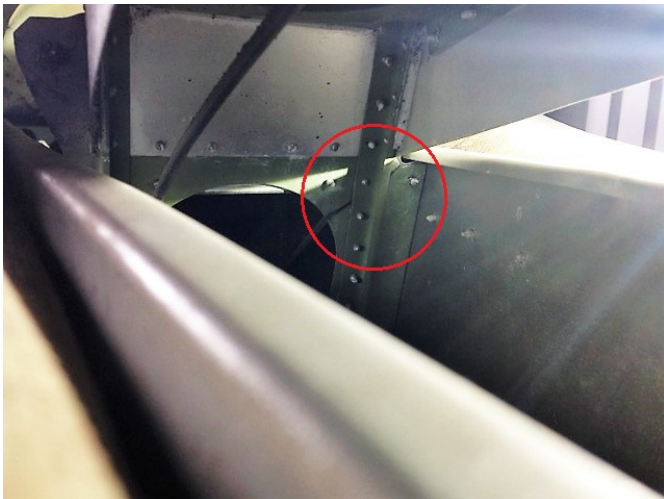
Sheered rivets and cracks running across the rear fuselage bulkhead below the attachment pins. Cracks and sheered rivets can occur on both sides effectively separating the front attachment of the tail plane from the lower fuselage (see Figure 1) . This may be caused by normal service and/or ground handling the tail plane. As a result of this defect the design of the bulkhead was changed in late 2013 (figure 2).

Figure 1 View from rear when the tail plane is removed showing cracked rear fuselage bulkhead.

Cracks and sheered rivets may result in the failure of the integrity of the tail plane attachment resulting in either the loss of the tail plane or loss of control during flight. **If a crack is found, the aircraft must not be flown. Please inform Light Sport Aviation as soon as possible.**

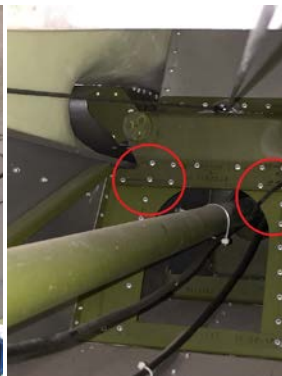
Figure 5 shows the view from the front through the rear fuselage floor inspection hatch using a digital camera. In bright light it may be necessary to cover the hole in which the elevator push rod runs to produce a sharp image of the area under inspection.

Remove the four screws attaching the rear access panel to the fuselage (figure 3). With a bright torch or a borescope view the front of the rear fuselage bulkhead and inspect for cracks. An inspection mirror may also be used. Alternatively a digital camera may be inserted into the inspection hole to take a photograph of the inspection area (figure 4). The image can then be inspected in and around the area indicated by the red circles for any deformation, cracks and sheered rivets (figure 5). After inspection re-attach the access panel cover.
