SERVICE BULLETIN SB/EUR/016 ISSUE 1
Amateur Kit and Factory Built Aircraft
Engagement of wing flap actuator pin into the flap guide

Date: 07 May2015

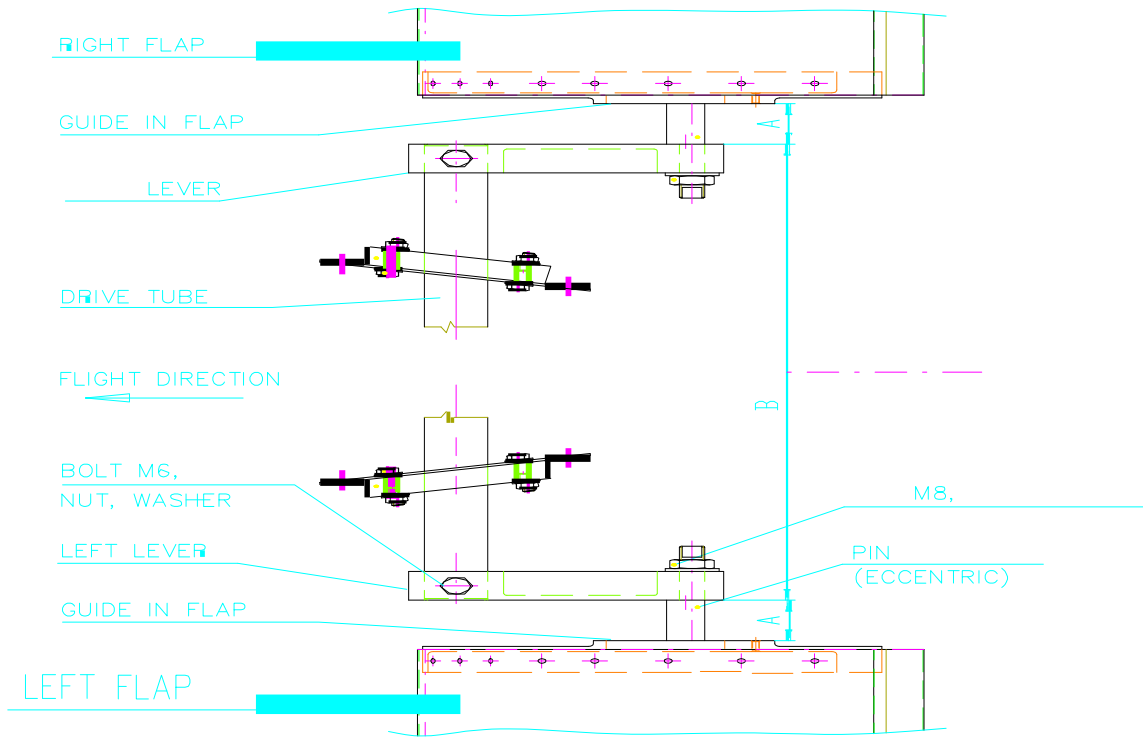
Fig.1

1. Check the engagement of the flap drive pins into the flaps. With reference to Fig 1, check the clearance between the drive lever with the pin and the nearest surface of the guide in

the flap rib – dimension A. Check this clearance for each flap when at full deflection of 50°. This can be done using a vernier calliper or a ruler.

If the exposed length of the pin (dimension A) is less than or equal to 17 mm, no further action is required.

If the measured dimension A is greater than 17mm but less than or equal to 20 mm, adjust the pin as specified in 2. below. If the measured dimension A is greater than 20 mm, Contact Light Sport Aviation.

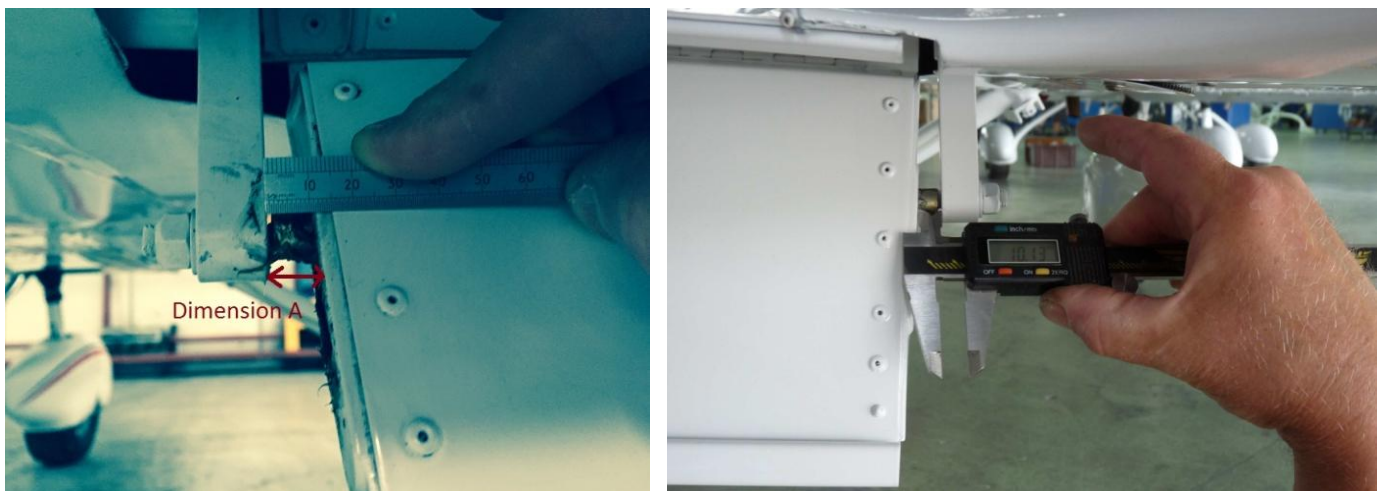
Fig. 2 – Measuring dimension A.

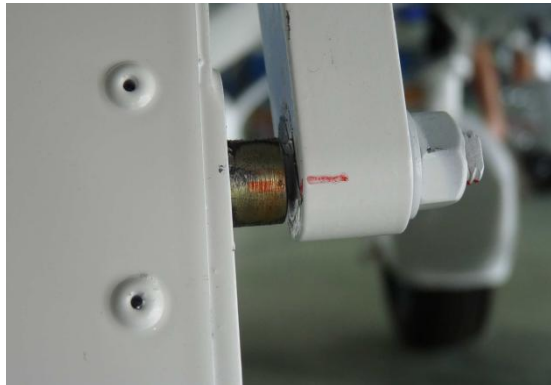
Fig. 3 – Marking the pin position

- a. With reference to Fig. 3, mark the position of pin's angular displacement (the pin is eccentric).
- b. Release the nut securing the pin.
- c. Unscrew the pin by 1 or 2 complete turns to increase the distance between the shoulder of the pin and the lever., see Fig. 4. This distance must not exceed 3 mm.
