SERVICE BULLETIN NUMBER 150 issue A

TITLE Unfused wiring and fire hazard
CLASSIFICATION P&M Aviation have classified this service bulletin as essential.
COMPLIANCE Inspection at Permit revalidation or within next 25 hours, whichever is less.
APPLICABILITY All Flight Design CT2K, CTSW and CTSL.

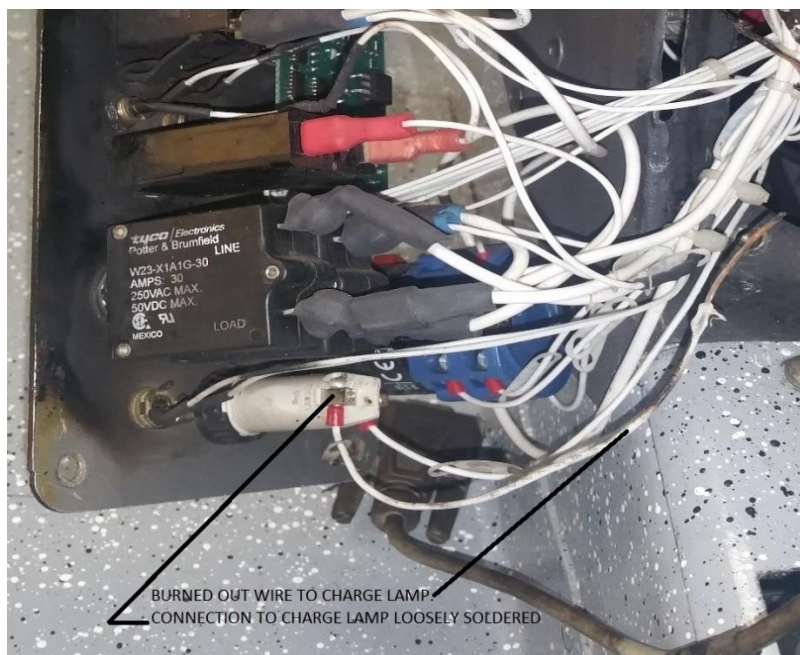
A CTSW suffered an in-flight fire in the cockpit. Fortunately, the aircraft was landed safely, and the fire extinguished with CO₂. The fire was caused by the charge lamp +12v supply wire which was trapped in a panel joint and had chafed and shorted to earth through the carbon structure. The charge indicator lamp on this aircraft had been moved from its normal position on the top of the upper instrument panel to the bottom of the centre console and was fed by a loose wire. The wiring was generally very untidy, with loose connections and several after-market equipment additions.

Shorting to carbon/epoxy is hazardous because the material is resistive and does not conduct heat well. Great heat is produced causing the resin to ignite. Once it is alight, the resin will continue to burn, producing smoke.

Fire damage. Note the burned-out wire running to the charge lamp, and the missing screw to the charge lamp replaced with a loose solder blob on the wire.

Remove the lower console panel. Inspect the condition and security of the wiring, especially the charge lamp +ve supply wire.

In order to minimise the run of unprotected wire, unless it is very short in length and supported so that a short circuit to earth is impossible, it is recommended to put a 1A fuse in the supply wire to the charge lamp, close to the regulator (modification M342). See wiring diagram in appendix A.

If the lamp wire needs replacing or rerouting, only non-PVC insulation of AWG22 gauge (P&M part no. 55A0811-22-9) may be used.

Ensure the wiring is tidy with tight connections and is well secured and protected. Be sure the wiring cannot be trapped in panel joints and has adequate strain relief. Ensure it cannot short against anything including control runs, at all extremes of movement.
