**EVEKTOR - AEROTECHNIK a.s.**

**SERVICE BULLETIN No.:**

**EV97 – 024a**

1. **CONCERNING:** All models of EV-97 EuroStar, SportStar and Harmony LSA aircraft.
2. **REASON:** A disconnected fuel hose from the non-shouldered end of T fitting in the joint secured by the clip was detected on the aircraft with registration number N821EV (S/N 20070821).

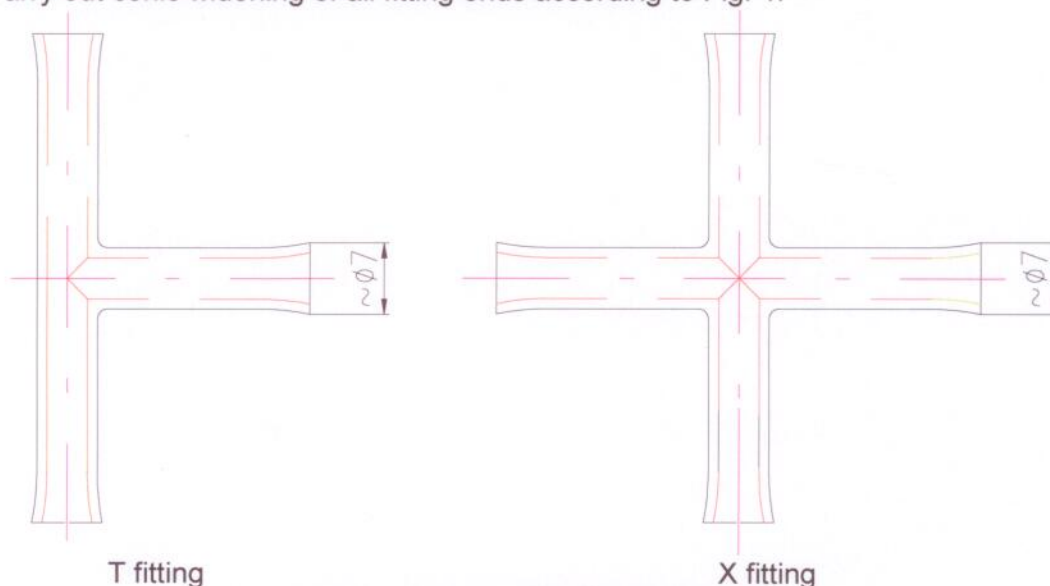
Fig. 1 – Widening of fitting ends

During manufacturing these fittings were modified. The ends of fittings were widened in order to secure the hoses properly.

Check all T- and X-fittings mounted in the engine compartment up to the fuel filter in the cockpit. Remove the clips from the fittings and disconnect the hose ends. Check the fittings. If their ends are not widened, modify them according to point 1.4.

Carry out conic widening of all fitting ends according to Fig. 1.
