KIT BUILT EV-97 & EV97A EUROSTAR AIRCRAFT
SERVICE BULLETIN SB-EV-97-10
INSPECTION AND RECTIFICATION OF RUDDER TOP BEARING

Classification - Recommended

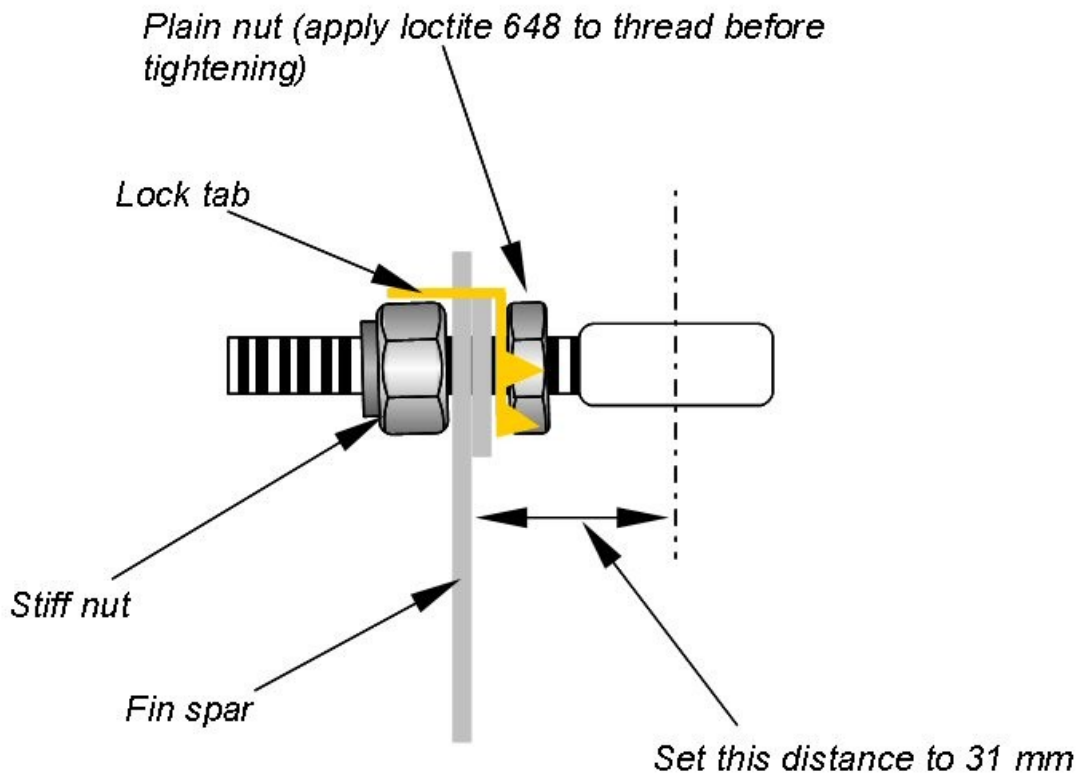
The diagram below shows the correct assembly after rectification. In addition to the tab washer use a drop of loctite 648 on the thread of the plain nut for additional security, but make sure no loctite gets on to the rudder pivot of the rose joint.

The 31mm dimension is what all UK factory built aircraft are set at, but homebuilt aircraft may be slightly different. Either check the original dimension before dismantling, or after assembly check there is full and free movement of the rudder in both directions, and the front of the rudder is visually parallel with the rear of the fin.

If the top rudder bearing is loose, rectification must be carried out in accordance with Appendix 2, but if there is any wear in the hole in the spar, consult with Cosmik Aviation before proceeding. Please note that the tab washer should be fitted behind the spar (against the rear face as shown in diagram) and not in front as previously. Tab washers are available from Cosmik Aviation.

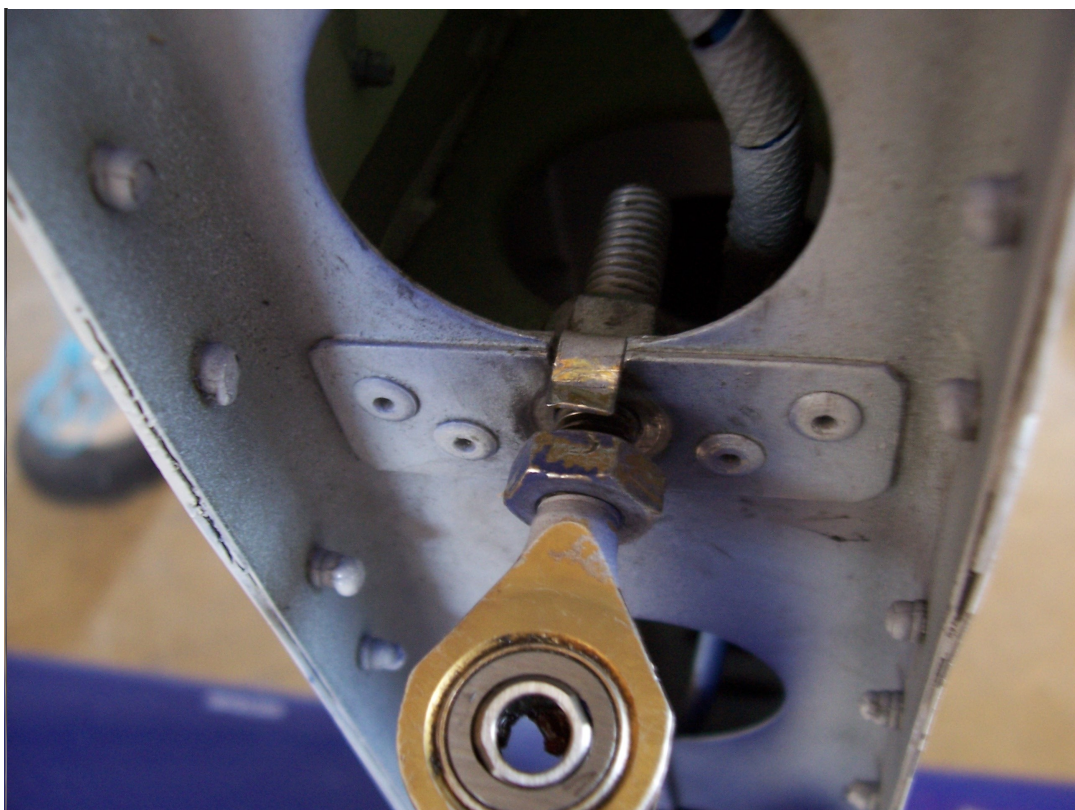
It has been reported by Evektor from the Czech Republic that a loose upper rudder bearing has been discovered. The upper bearing consists of a rose joint fitted to the fin spar by a self locking nut to the front, and a plain nut secured with a tab washer at the rear. The photograph in Appendix 1 shows the loose bearing, showing the loosened plain nut, which had been improperly secured by the tab washer.

Loose upper hinge of the rudder

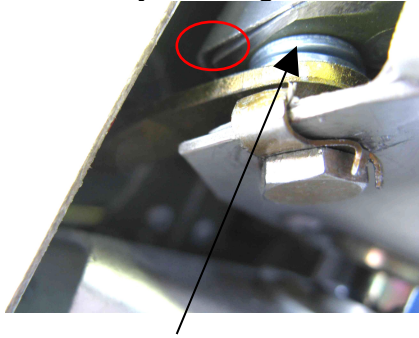
Note: The two „normal“ washers above the cable ends are installed to prevent cables from being chafed from the rudder front lower edge (marked red). Installation of these washers is recommended if not installed and there is an evidence of chafing in this area.

19. Set new tab washers (size 6) on the cable attachment screws.

20. Re-connect the cables and screw down the screw. Secure screw heads against release by bending the washer tabs.
