## SERVICE BULLETIN SB/EUR/07 Issue 1

### EV-97 teamEurostar UK Aircraft, Rudder Stop Swages

17<sup>th</sup> August 2011

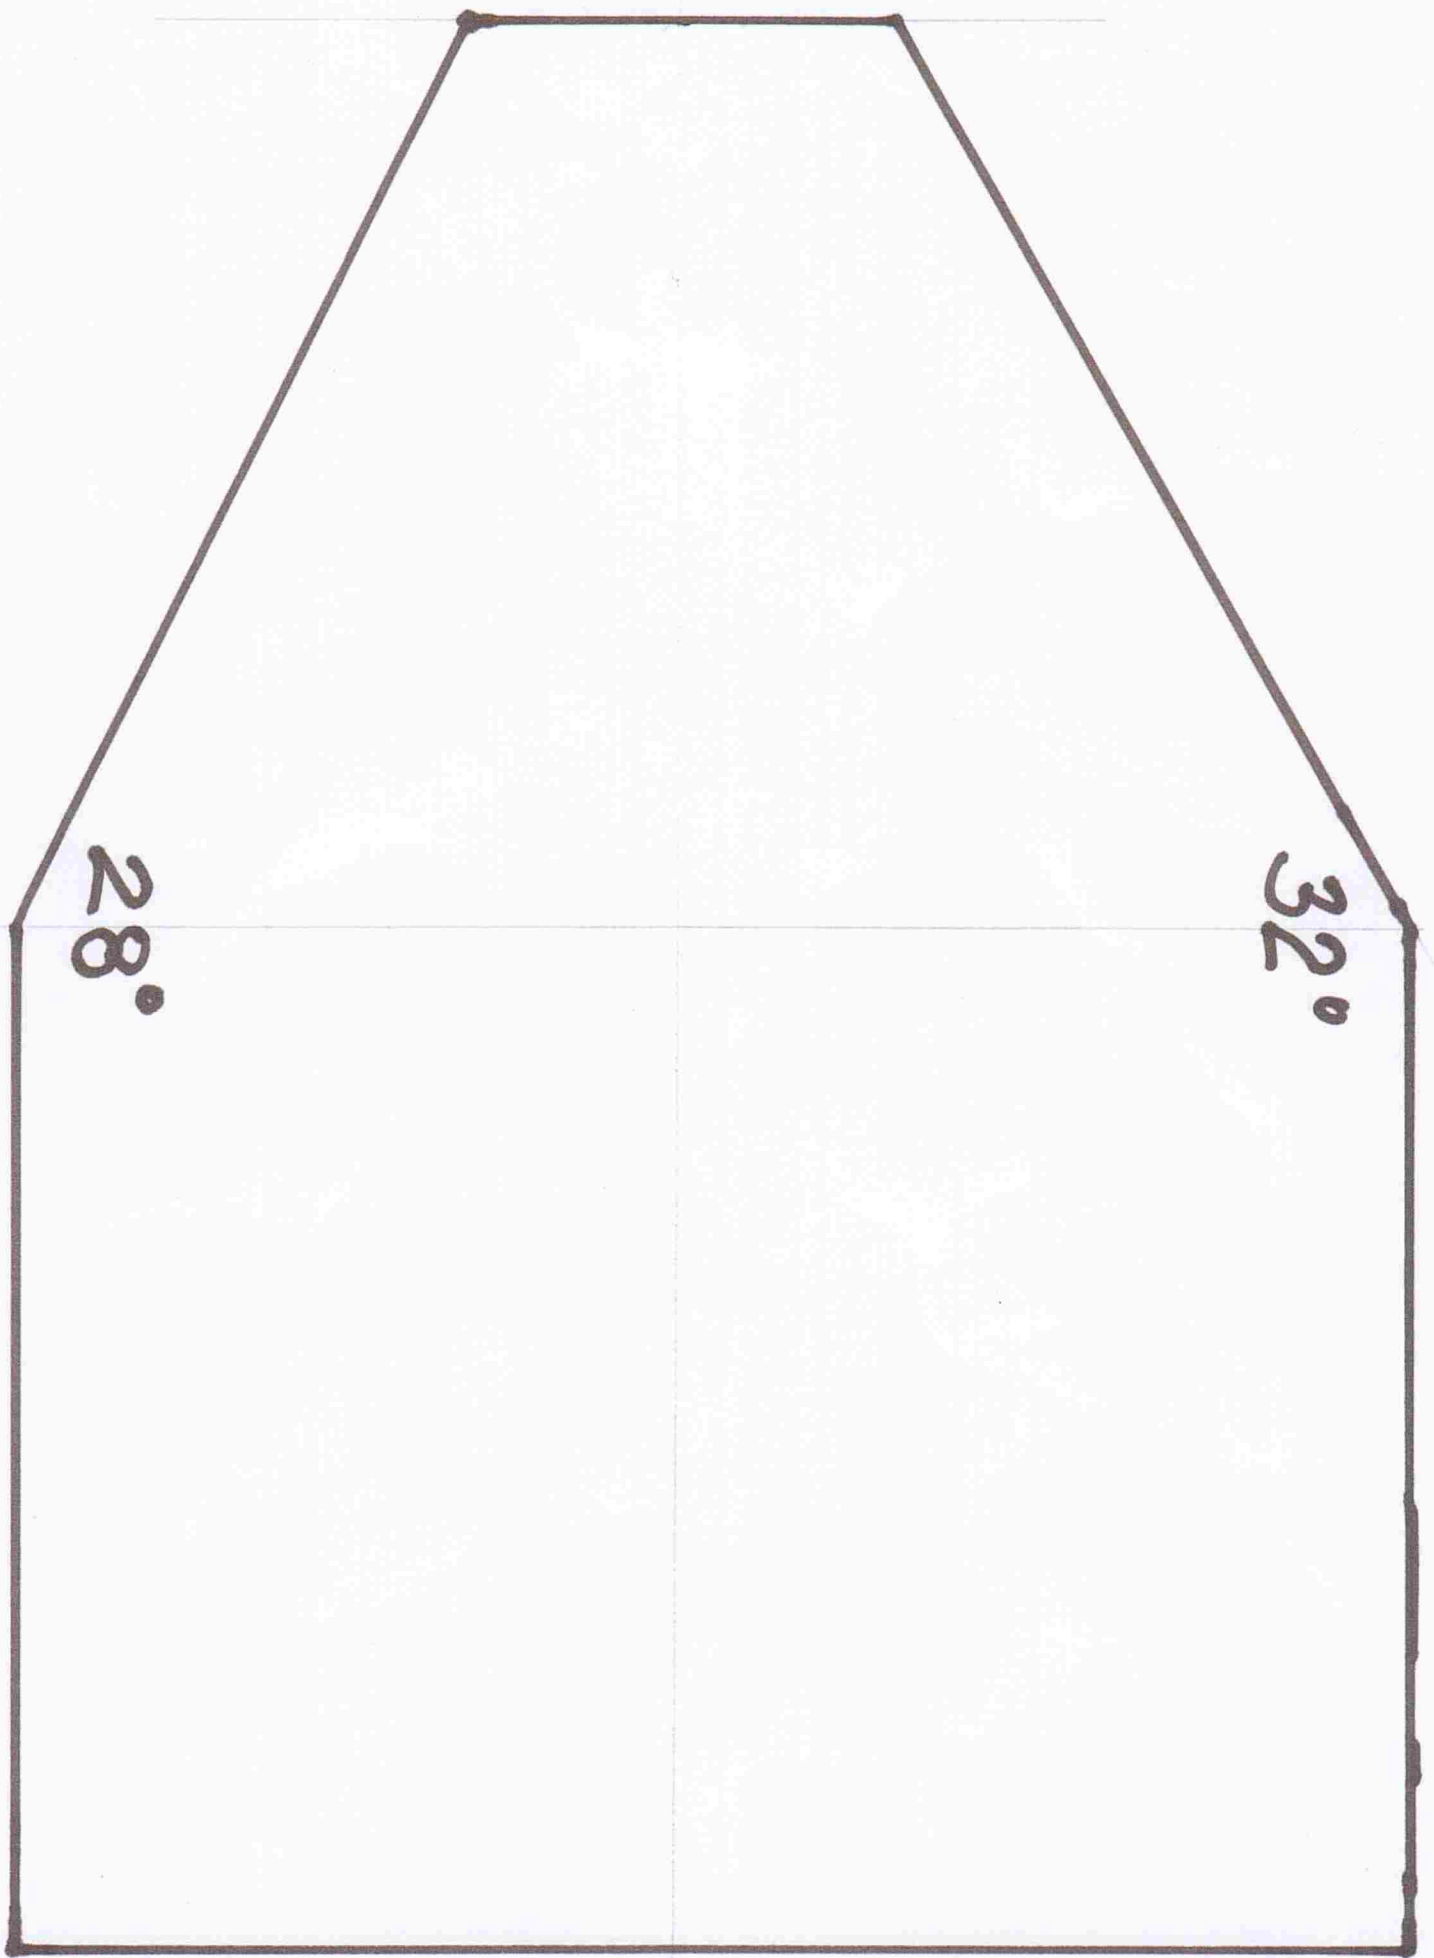
**A) Note:** Check if the swaged rudder cable stops have moved by measuring the rudder deflections. The deflections can be checked using the drawing at the end of this bulletin.

Make a template by pasting the drawing onto a sheet of stiff card and cutting round the heavy line. Get a helper to push one outer rudder pedal until the stop just contacts and then check that the deflection is between  $32^{\circ}$  and  $28^{\circ}$  using the template. Repeat with your helper pressing the other rudder pedal.

13. When the joints are completely cured, adjust the stops to achieve a rudder deflection of  $30^{\circ} \pm 2^{\circ}$  in each direction. Tighten the locknut and paint tell-tale on the locknut and female adjustment nipple. Note that the stops should be positioned so that the adjusters on both sides touch the nylon block assemblies at the same time.
